Plumb's Chambers gets \$1 million restoration

7th Mar 2015 5:00 AM

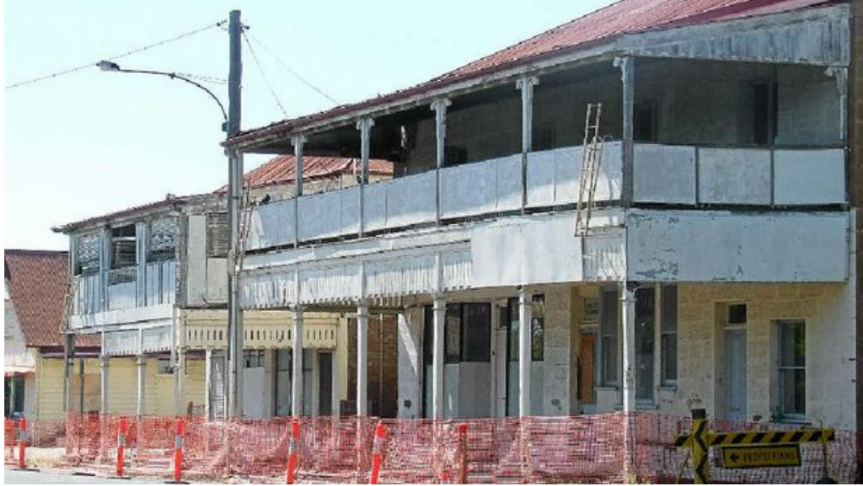
RIGHT, the building before the restoration process began.

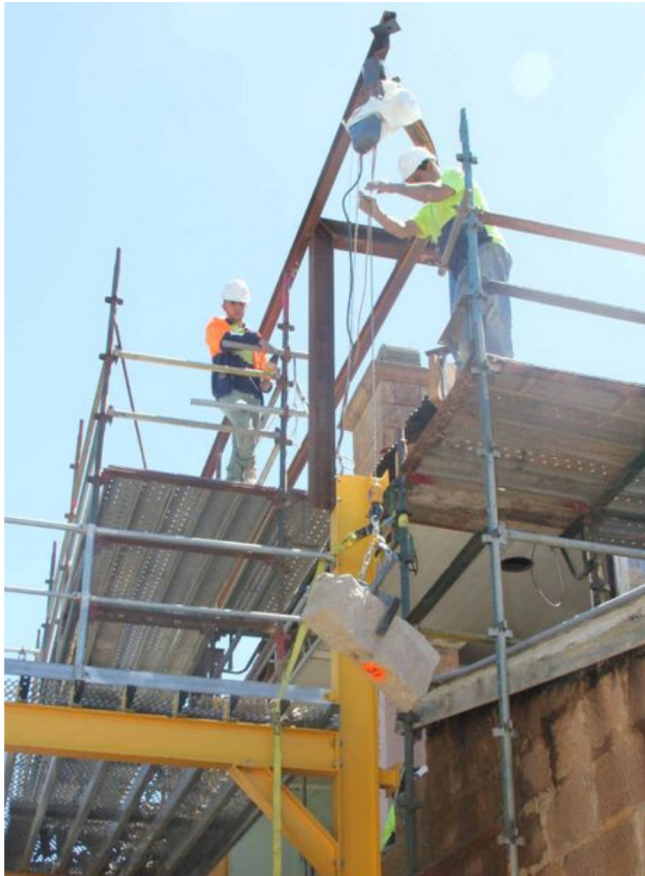
Workers deconstructing the western wall, stone by stone.

According to stonemason George Francis, who has recently completed the restoration of one of Sydney's oldest homes, Cleveland House in Surry Hills, the western wall of Plumb's Chambers was leaning out almost 180mm.

"It was about to fall over onto the driveway," Mr Francis said. "So McConaghys went out and built a gantry so it wouldn't fall over."

"We deconstructed it stone by stone, numbering every single stone that came off the building

where it was, bringing it all down back to the ground," Mr Francis said.

"Then we poured a new footing under it and brought the wall back up exactly the way it was, every single piece. We fixed the broken stones, reinstated the new lintel, and brought it back up again."

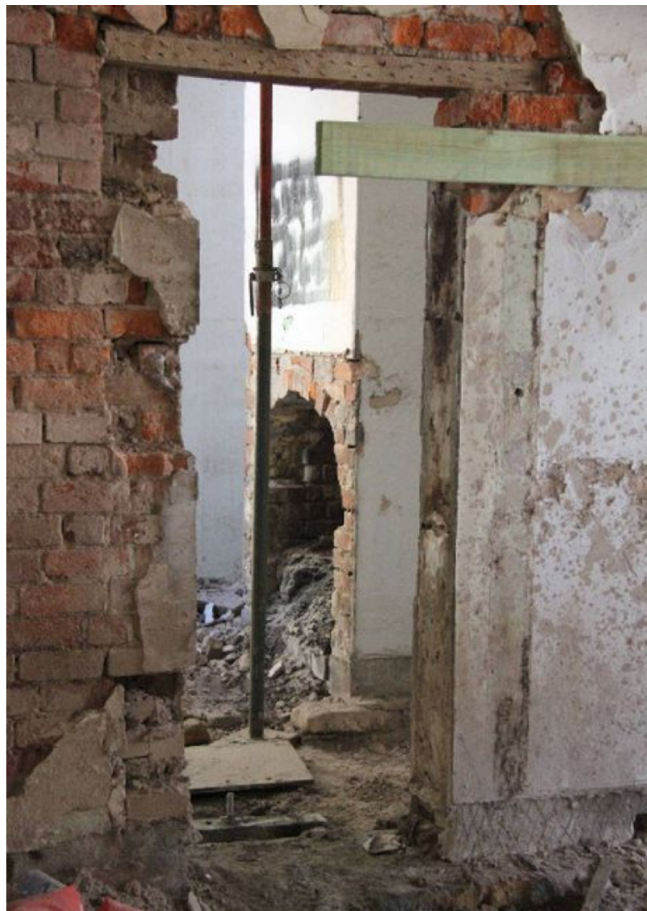
The internal rooms of the iconic building are severely dilapidated.
